Contract Report

September 1991

**SOIL BIOENGINEERING
CORPORATION
MARIETTA, GA**

**SOIL BIOENGINEERING
MAJOR GULLY WASHOUT REPAIR,
SILVERHILL AIRFIELD,
BALDWIN COUNTY, ALABAMA**

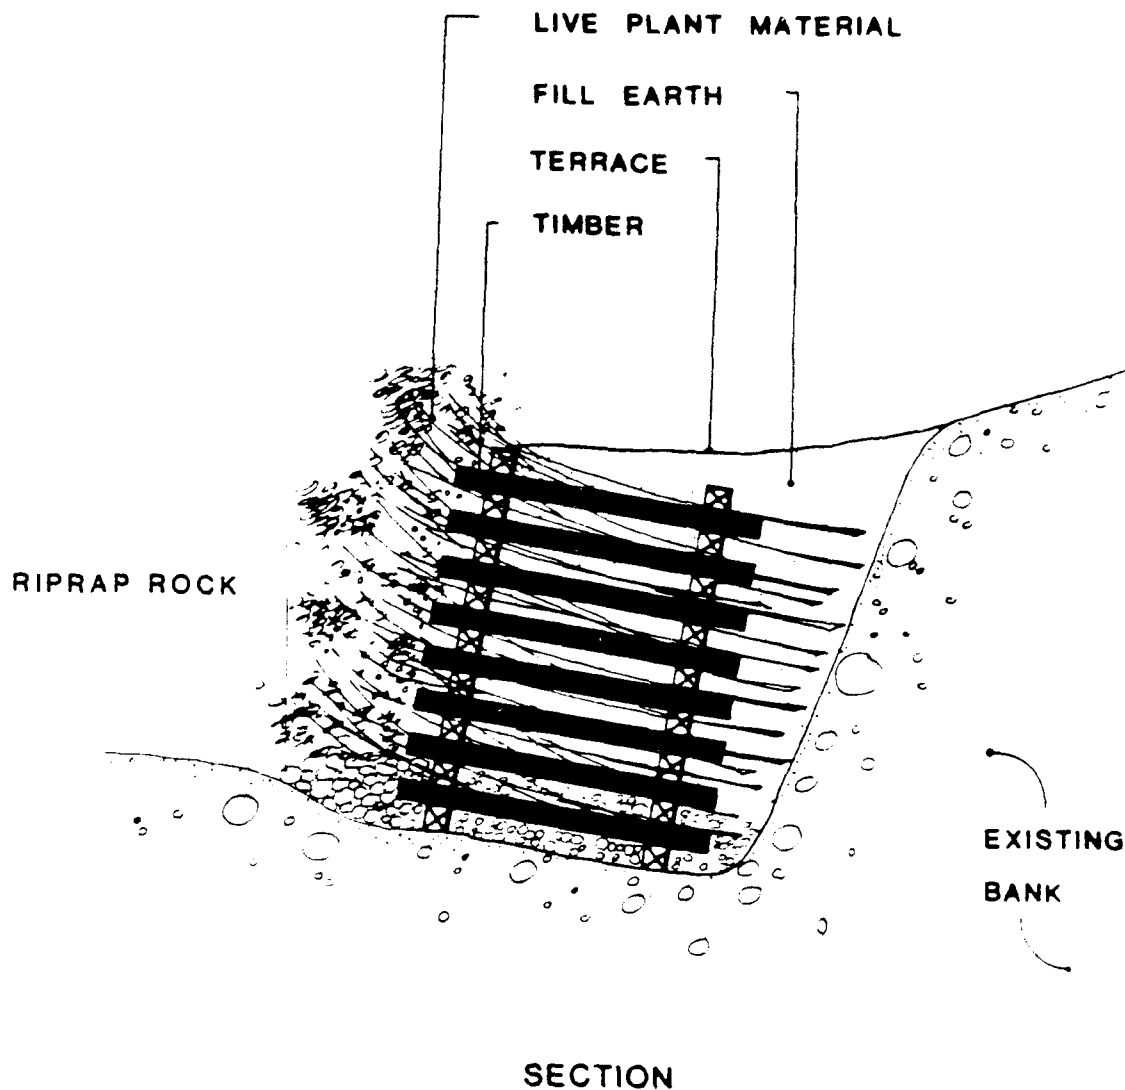
FIGURE 1

Live Cribwall - See Figure 1. This system was built with timbers, forming an open, box-like structure. As it was built, live plant materials were incorporated at each layer. The live cribwall began to root internally and is expected to root into the bank behind, causing the entire area to become stabilized. The cribwall was placed below the first built grade structure.

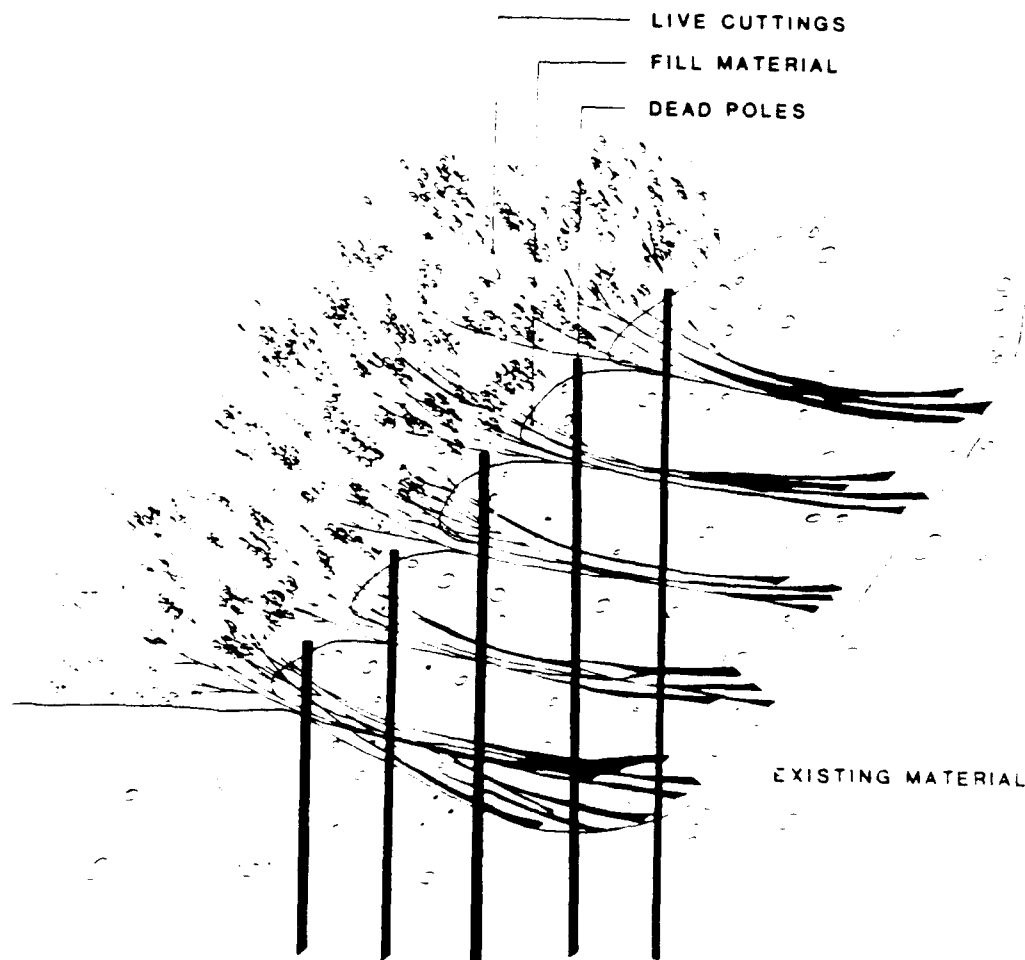
FIGURE 5

Branchpacking - See Figure 5. The live branches were placed directly in a critical fill area, at an angle in the bottom of the repair fill site. A layer of earth was placed on top of each successive layer to give immediate soil reinforcement and to serve as a brush filter/sediment barrier. This construction is expected to slow the water velocities and capture silts. The live branches are expected to root into the placed fill. This system was used to tie together the left side of the upper existing conventional drop structure and live cribwall into the graded slope.

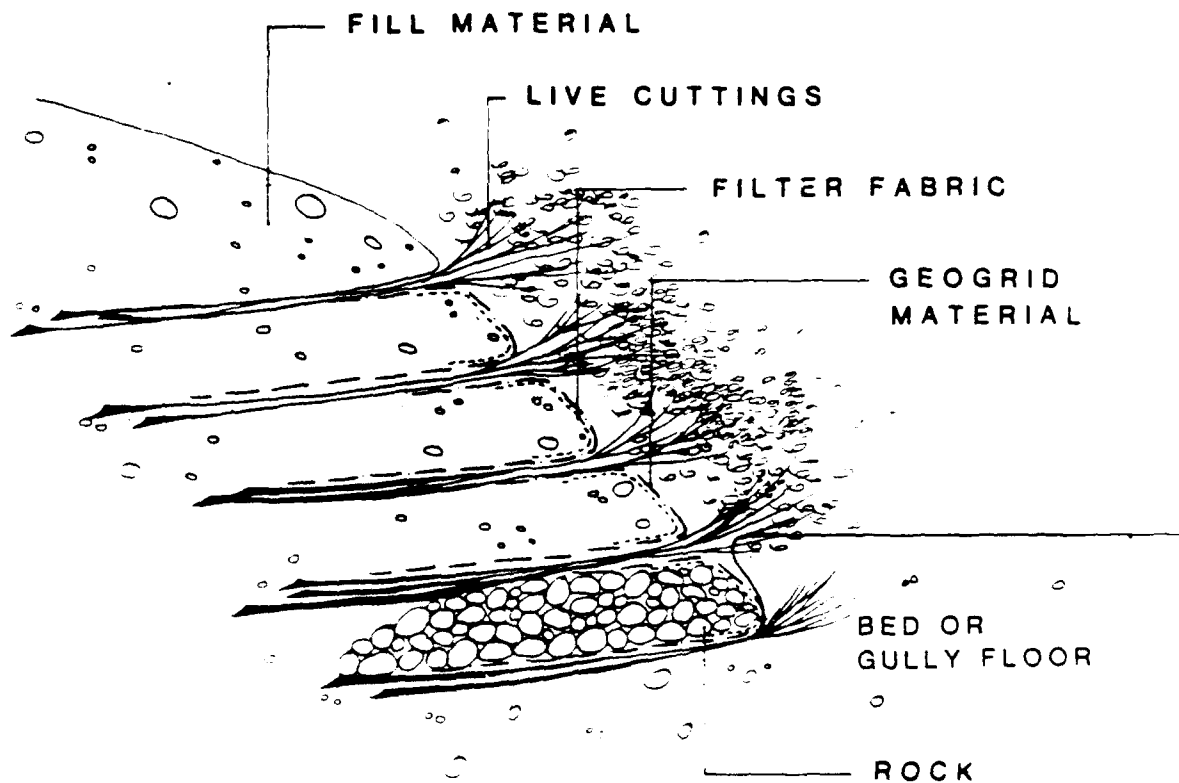
FIGURE 7

Live Soft Gabions (Vegetated Geogrids) - See Figure 7. These live systems were placed five (5) feet deep in prepared terraces in the same manner as the previously described brushlayers. In addition to the living brush, the soil layers which are in between the live branches, were wrapped with geotextile material to give added strength in the critical areas.
